WORKSHOP MEETING BOARD OF TRUSTEES

There will be a Workshop Meeting of the Board of Trustees of the Portland Water District on Monday, April 8, 2024. The meeting will begin at 6:30 p.m. in the Nixon Training Center at the general offices of the District located at 225 Douglass Street, Portland, Maine.

Facility: Standish Water Treatment

Roof Section: Metal Roof

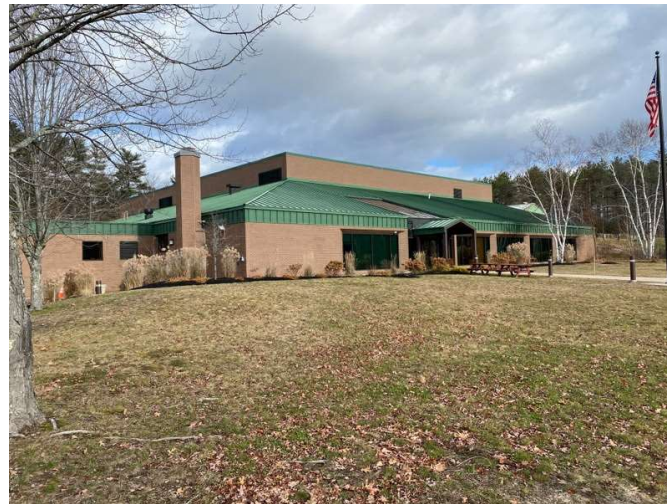
This roof is in failed condition for multiple reasons and I recommend planning/ budgeting for replacement. Two replacement options are available for this sloped roof sections: new metal roof or replace with shingles. Primary issues and recommendations are listed below.

- Issue: metal panel is tearing mid span due to assembly; panel is architectural and non structural, so it is weak and failing in many areas; panel seams are failing and are weak; panel is rusting at eaves; panel is poorly detailed at eaves/ gutters; panel should have been installed in one continuous piece instead of 2 per ridge to eave run.
- Solution:
 - Metal Option (~40 yr lifespan): replace with a true T Seam (Rmer Span) style roof over a fully adhered high temp underlayment. One continuous panel required from eave to ridge.
 - Shingle Option (~20 yr lifespan): install high temp underlayment and architectural shingles.

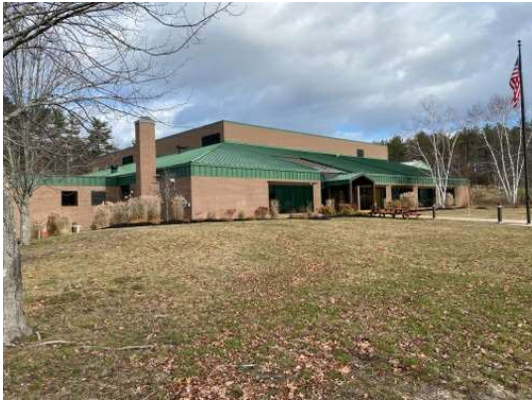
Photo 1

Metal roof overview.

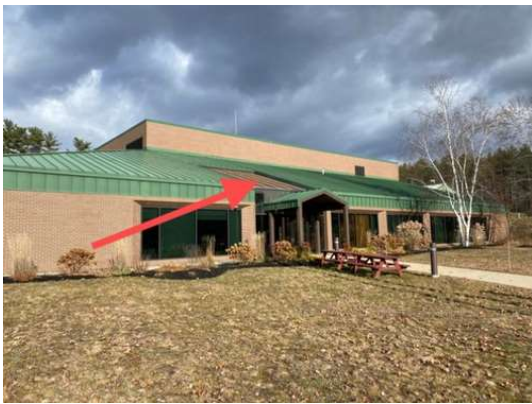
Photo 2

Glass "skylight" - storefront style.

This skylight is at/slightly below the metal roof line. Recommend either removing the skylight and roof over OR installing a different style skylight that is raised up ~8"-12" from the metal roof and sits on a curb. Instead of a drain/gutter unroof of the skylight (existing detail), install a saddle/cricket valley detail to pushes water/snow to either side of the new "skylight" assembly (engineering required).

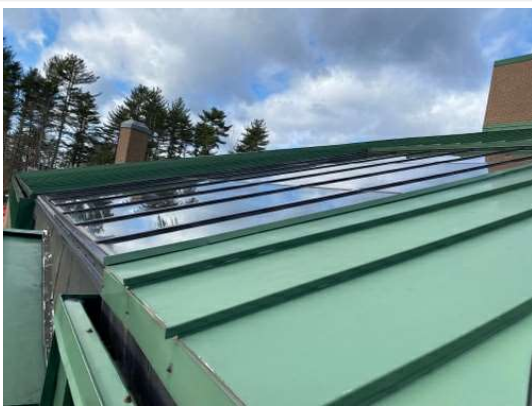
Photo 3

Overview of metal roof to skylight connection.

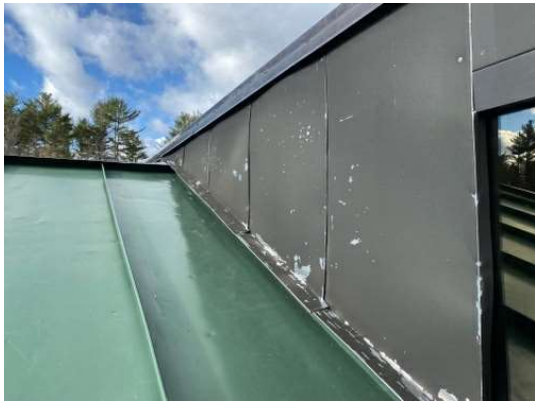
Photo 4

Metal wall panel at the eave edge of the main roof connecting to the gable entry roof. This metal wall panel is directly down roof of the skylight. Snow/ice slides off the skylight and onto this lower roof, which has over time damaged the lower entry roof and the metal wall panels.

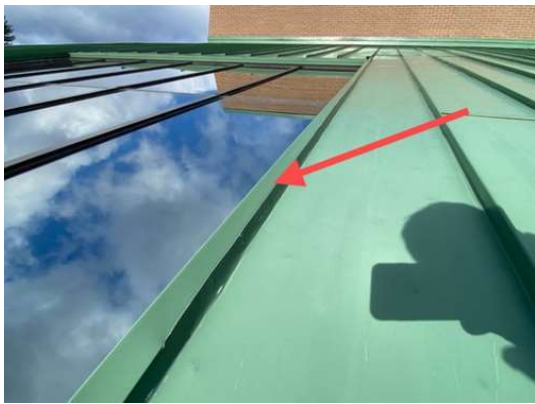
Photo 5

Difficult to show, but this entire metal seam connecting the skylight trim to the metal roof is completely unzipped itself and has created an open condition within the assembly allowing water into the building.

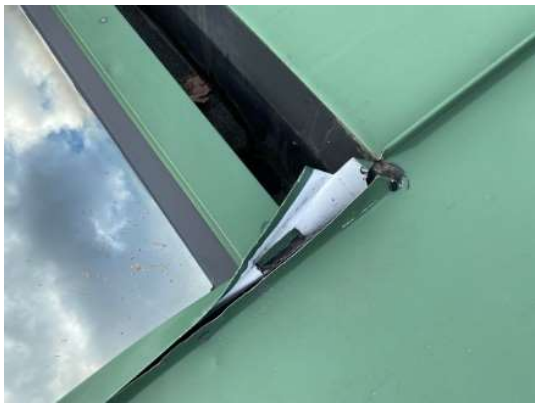
Photo 6

Another view of the same seam that has unzipped itself from the roof-to-skylight connection. This photo shows the transition of the metal panels uproof of the skylight. They are connected by an internal gutter lined with EPDM. These internal gutter are poorly designed and should be decommissioned (see additional photos and comments for further explanation).

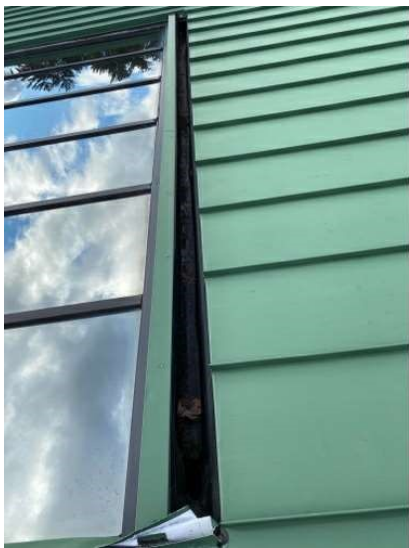
Photo 7

Overview of gutter/ internal drain connecting the upper metal roof panel to the skylight assembly.

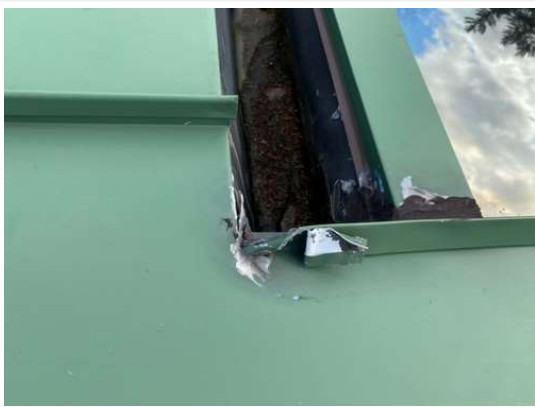
Photo 8

Another view of the opposite side of the metal roof to skylight assembly = open condition allowing water into your building. Decommission this detail at roof replacement.

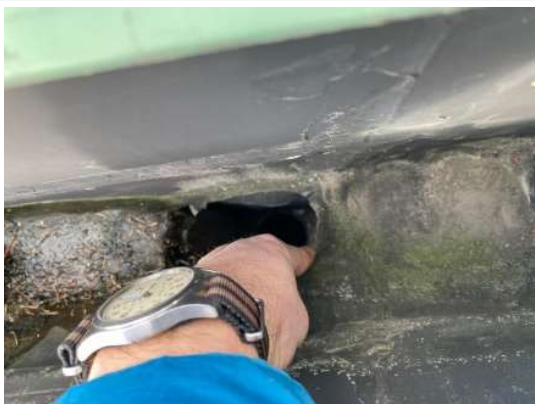
Photo 9

Internal drain within the skylight to metal panel transition.

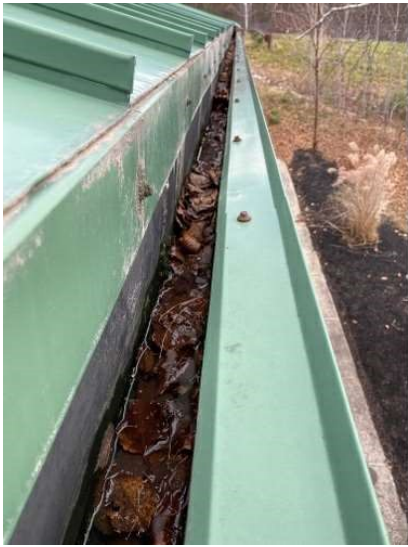
Photo 10

Internal drain assembly at eave. This gutter is positioned directly over the building envelope and funnels water to internal drains. It has failed in most locations due to the design/ function of the system.

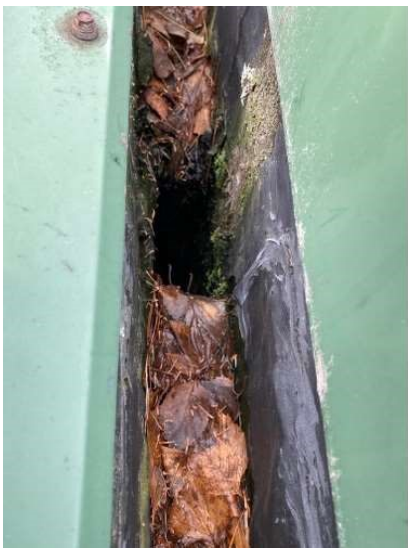
Photo 11

Gutter and internal drain overview.

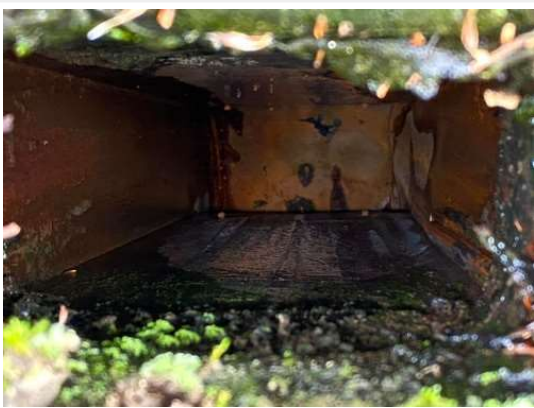
Photo 12

Looking down the the internal drain. Per architectural drawings, this drain makes a transition from square to round pipe, another potential weak point within a system that is within the building envelope.

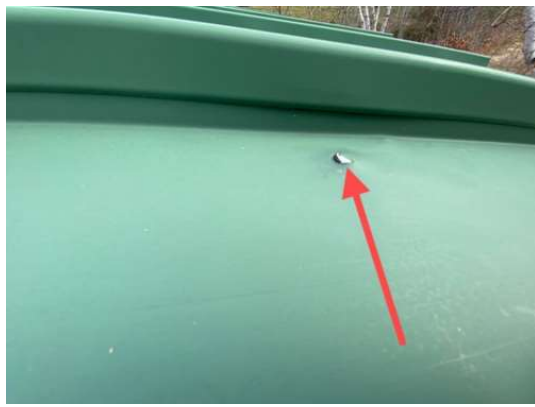
Photo 13

Roof panel inspection: tear in the metal panel over a seam clip where the fastener has backed out and the shearing effect of snow and ice has torn the metal = **OPEN CONDITION FOR WATER TO ENTER THE BUILDING**

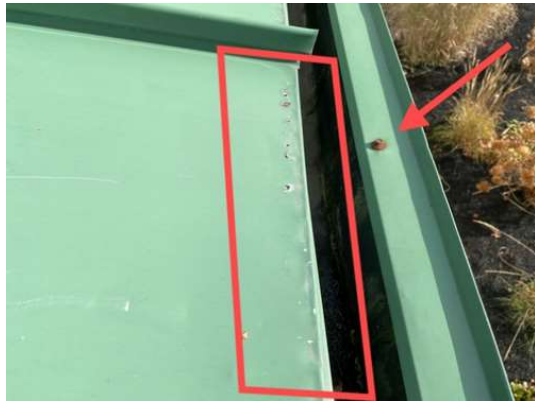
Photo 14

Damaged panels at the eave edge leading to rust of the steel panels and holes into the system (red outline). Rusting fasteners throughout the assembly, these will continue to fail.

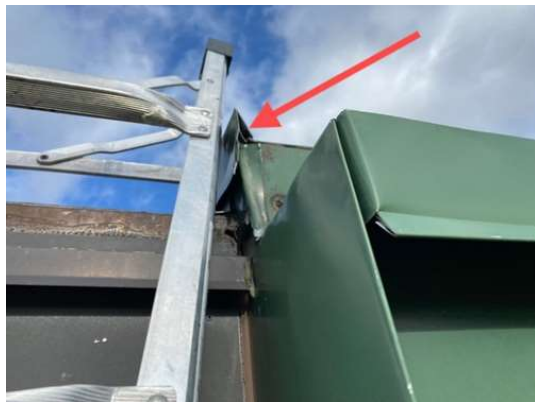
Photo 15

Connection of metal trim to the skylight - this entire connection detail should be improved/ updated.

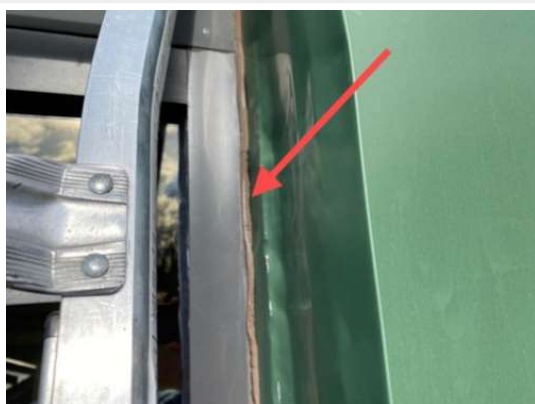
Photo 16

Caulking/ sealant connecting the vertical window just below the skylight to the metal panel. This area sees snow and ice buildup (as evident from the condition of green metal panel) and the sealant has failed/ needs to be replaced to keep water out of the assembly.

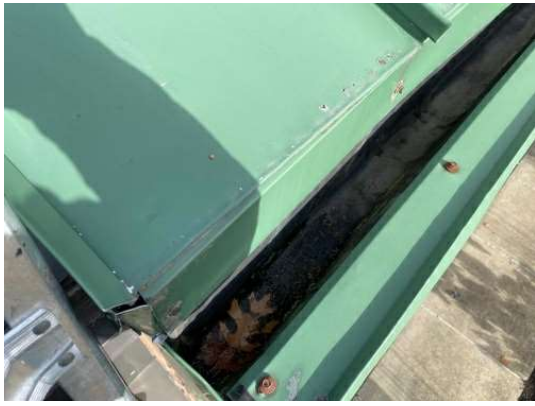
Photo 17

Overview of gutter assembly at eaves. Rusting metal panel at the eaves, gutters filled with leaves slowing flow of water. rusting fasteners, etc.

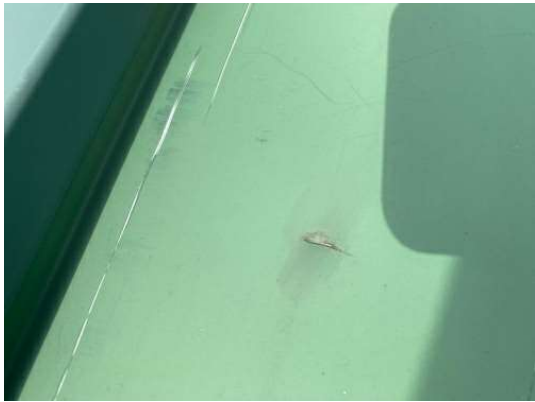
Photo 18

Tear in metal panel and scratching of metal panel most likely from trapped debris under sliding snow/ice.

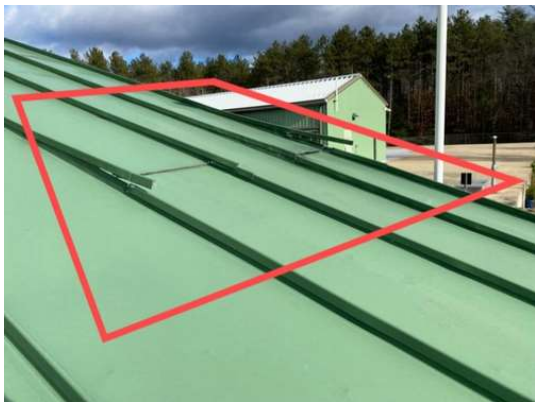
Photo 19

Seam caps pulling away from the standing seam roof. This is an **OPEN CONDITION FOR WATER TO ENTER THE BUILDING**

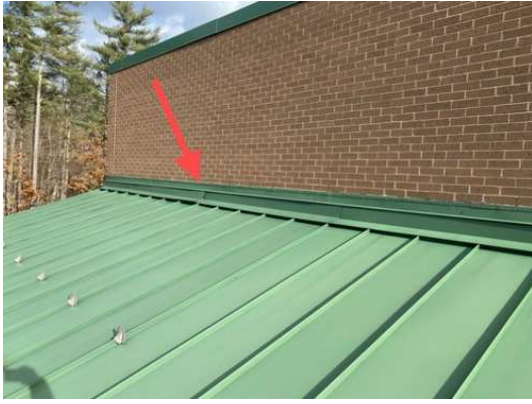
Photo 21

Failed head/ wall flashing for the masonry to metal roof transition. In areas where the masonry pins have failed, this section of counter flashing was blowing in the wind (see next photo), which give direct access for water to enter the building.

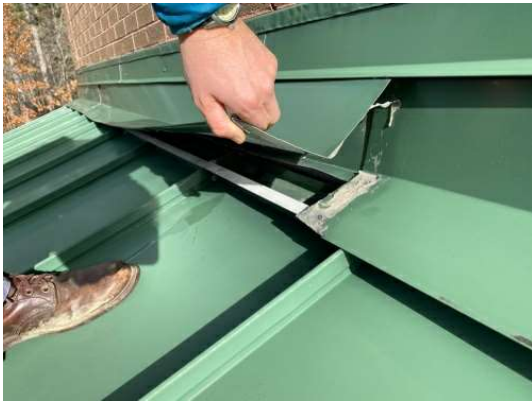
Photo 22

Flashing detail failure.

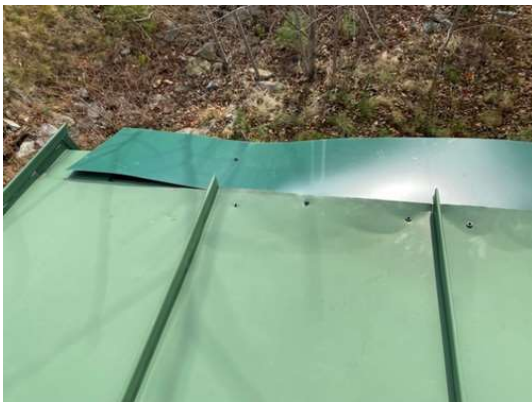
Photo 23

A DIY solution to stop leaks at the internal gutter detail. This light gauge flashing was tucked under the metal panel and fastened into the assembly a few month ago. Many screws have backed off and the metal flashing, although temporarily stopping many of the leaks, is not a long term solution as wind will shear the metal off creating an airborne hazard (see additional photos).

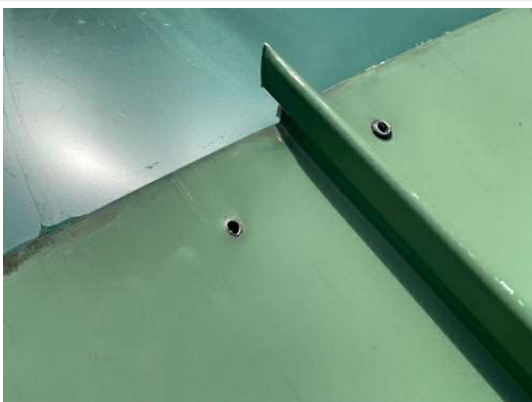
Photo 24

Screws that have sheered away due to wind moving the assembly. Now there are open conditions into the roof assembly.

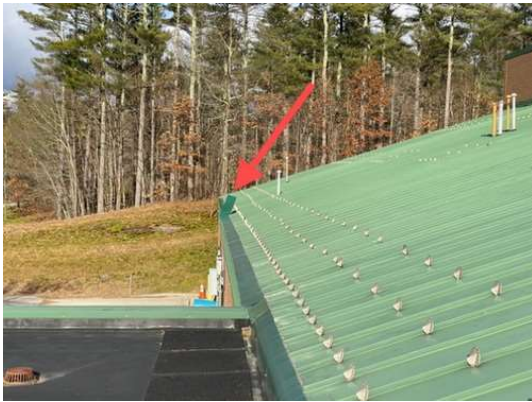
Photo 26

Wind catching the end of the flashing/ DIY solution. This was already starting to tear, so I removed this section while onsite during the inspection.

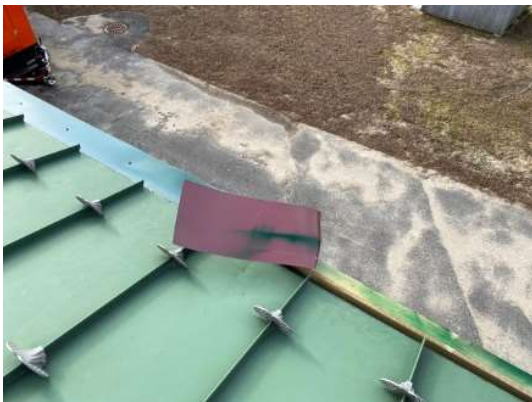
Photo 27

Failed DIY flashing detail at the roof eave to gutter detail. I removed this piece during the site visit so it wouldn't become airborne on a windy day.

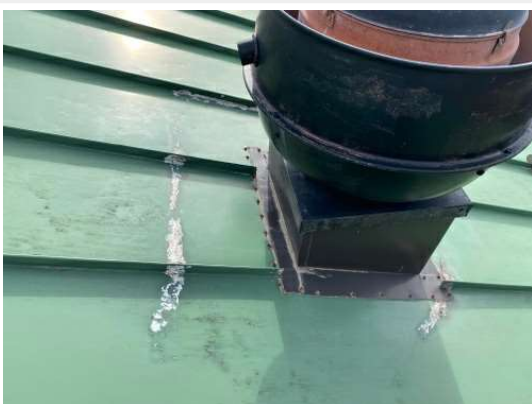
Photo 28

Improperly installed curb. The roofing panels should have been unseamed and removed to allow for a proper curb and pan assembly ideally installed with a cricket and valley. This curb flange was installed directly to the panels with sealants that will always fail over time as the curb limits the movement of the metal panel.

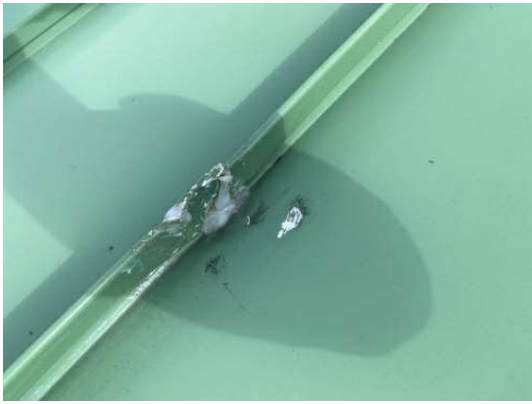
Photo 29

Silicon sealant installed at a failed seam where damage occurred along the way. This is not an acceptable repair.

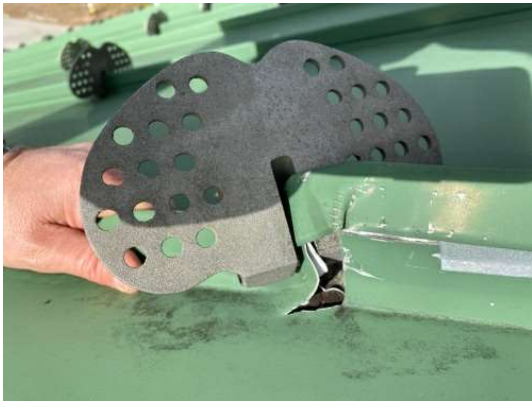
Photo 30

These rib mounted snow tabs are not an acceptable solution for snow management on an architectural metal panel roof. There are MANY snow tabs that have similarly torn the metal panel and created an open condition in the roof.

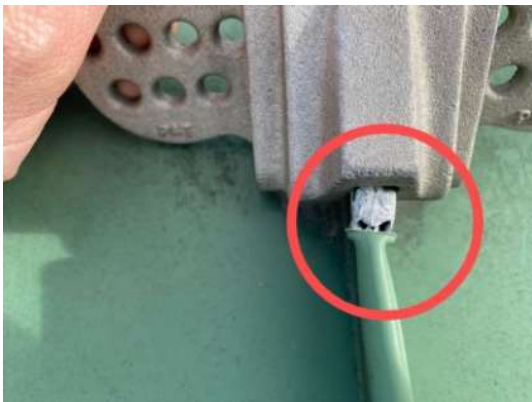
Photo 31

Movement in the snow tab has damaged the panel rib leaving an open condition for water to enter the building. This condition was found in MANY locations around the roof area.

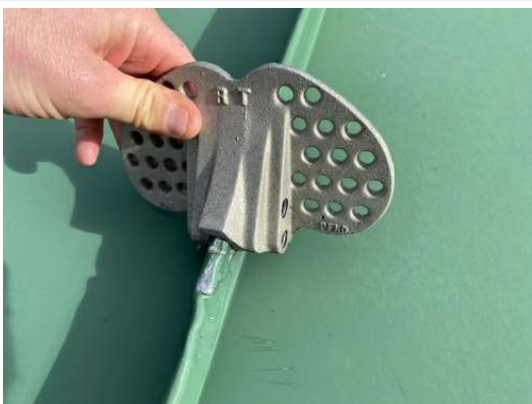
Photo 32

Additional open conditions at the snow tabs.

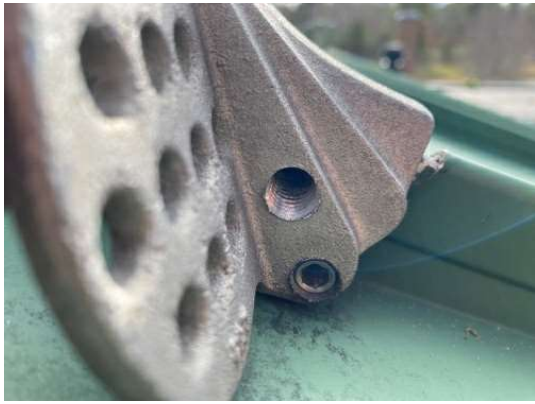
Photo 33

Only 1 fastener/ set screw was used to lock in the panel, this is what has allowed the snow tab to tear/ dent the metal panel rib.

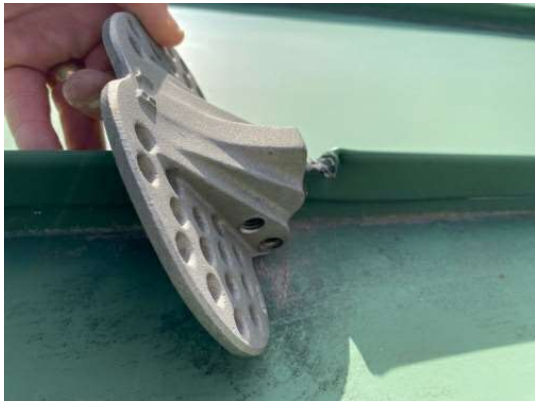
Photo 34

Additional open conditions at the snow tabs.

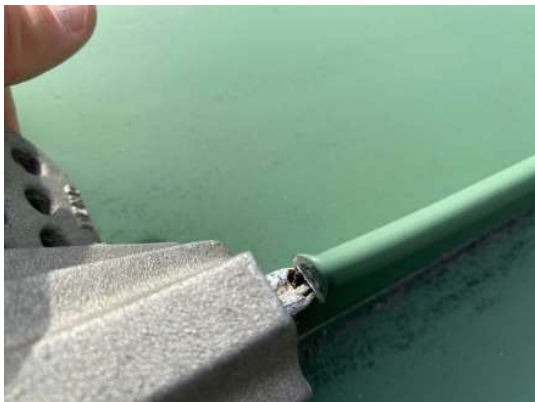
Photo 35

Additional open conditions at the snow tabs.

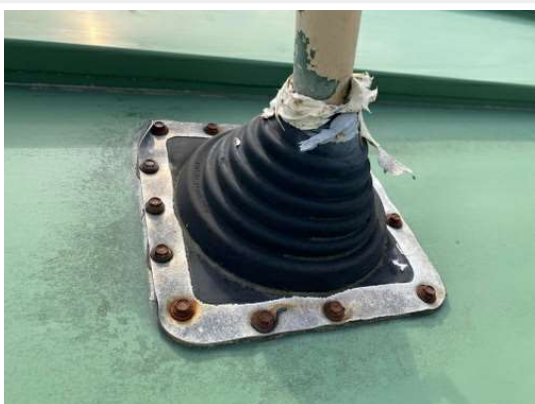
Photo 36

These pipe boots do not withstand the movement of snow. Note the corners of the metal around the boot are folding up. Stainless steel fasteners should be used as well.

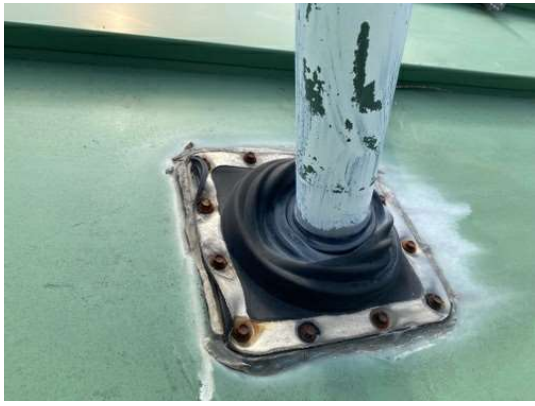
Photo 37

Failure at another pipe boot. No clamp ring used around the rubber to pipe connection.
